Name Of Dam: MOORE CREEK
Location: ROCKBRIDGE COUNTY
Inventory Number: VA. 16304

PHASE I INSPECTION REPORT NATIONAL DAM SAFETY PROGRAM

JUNE 1980

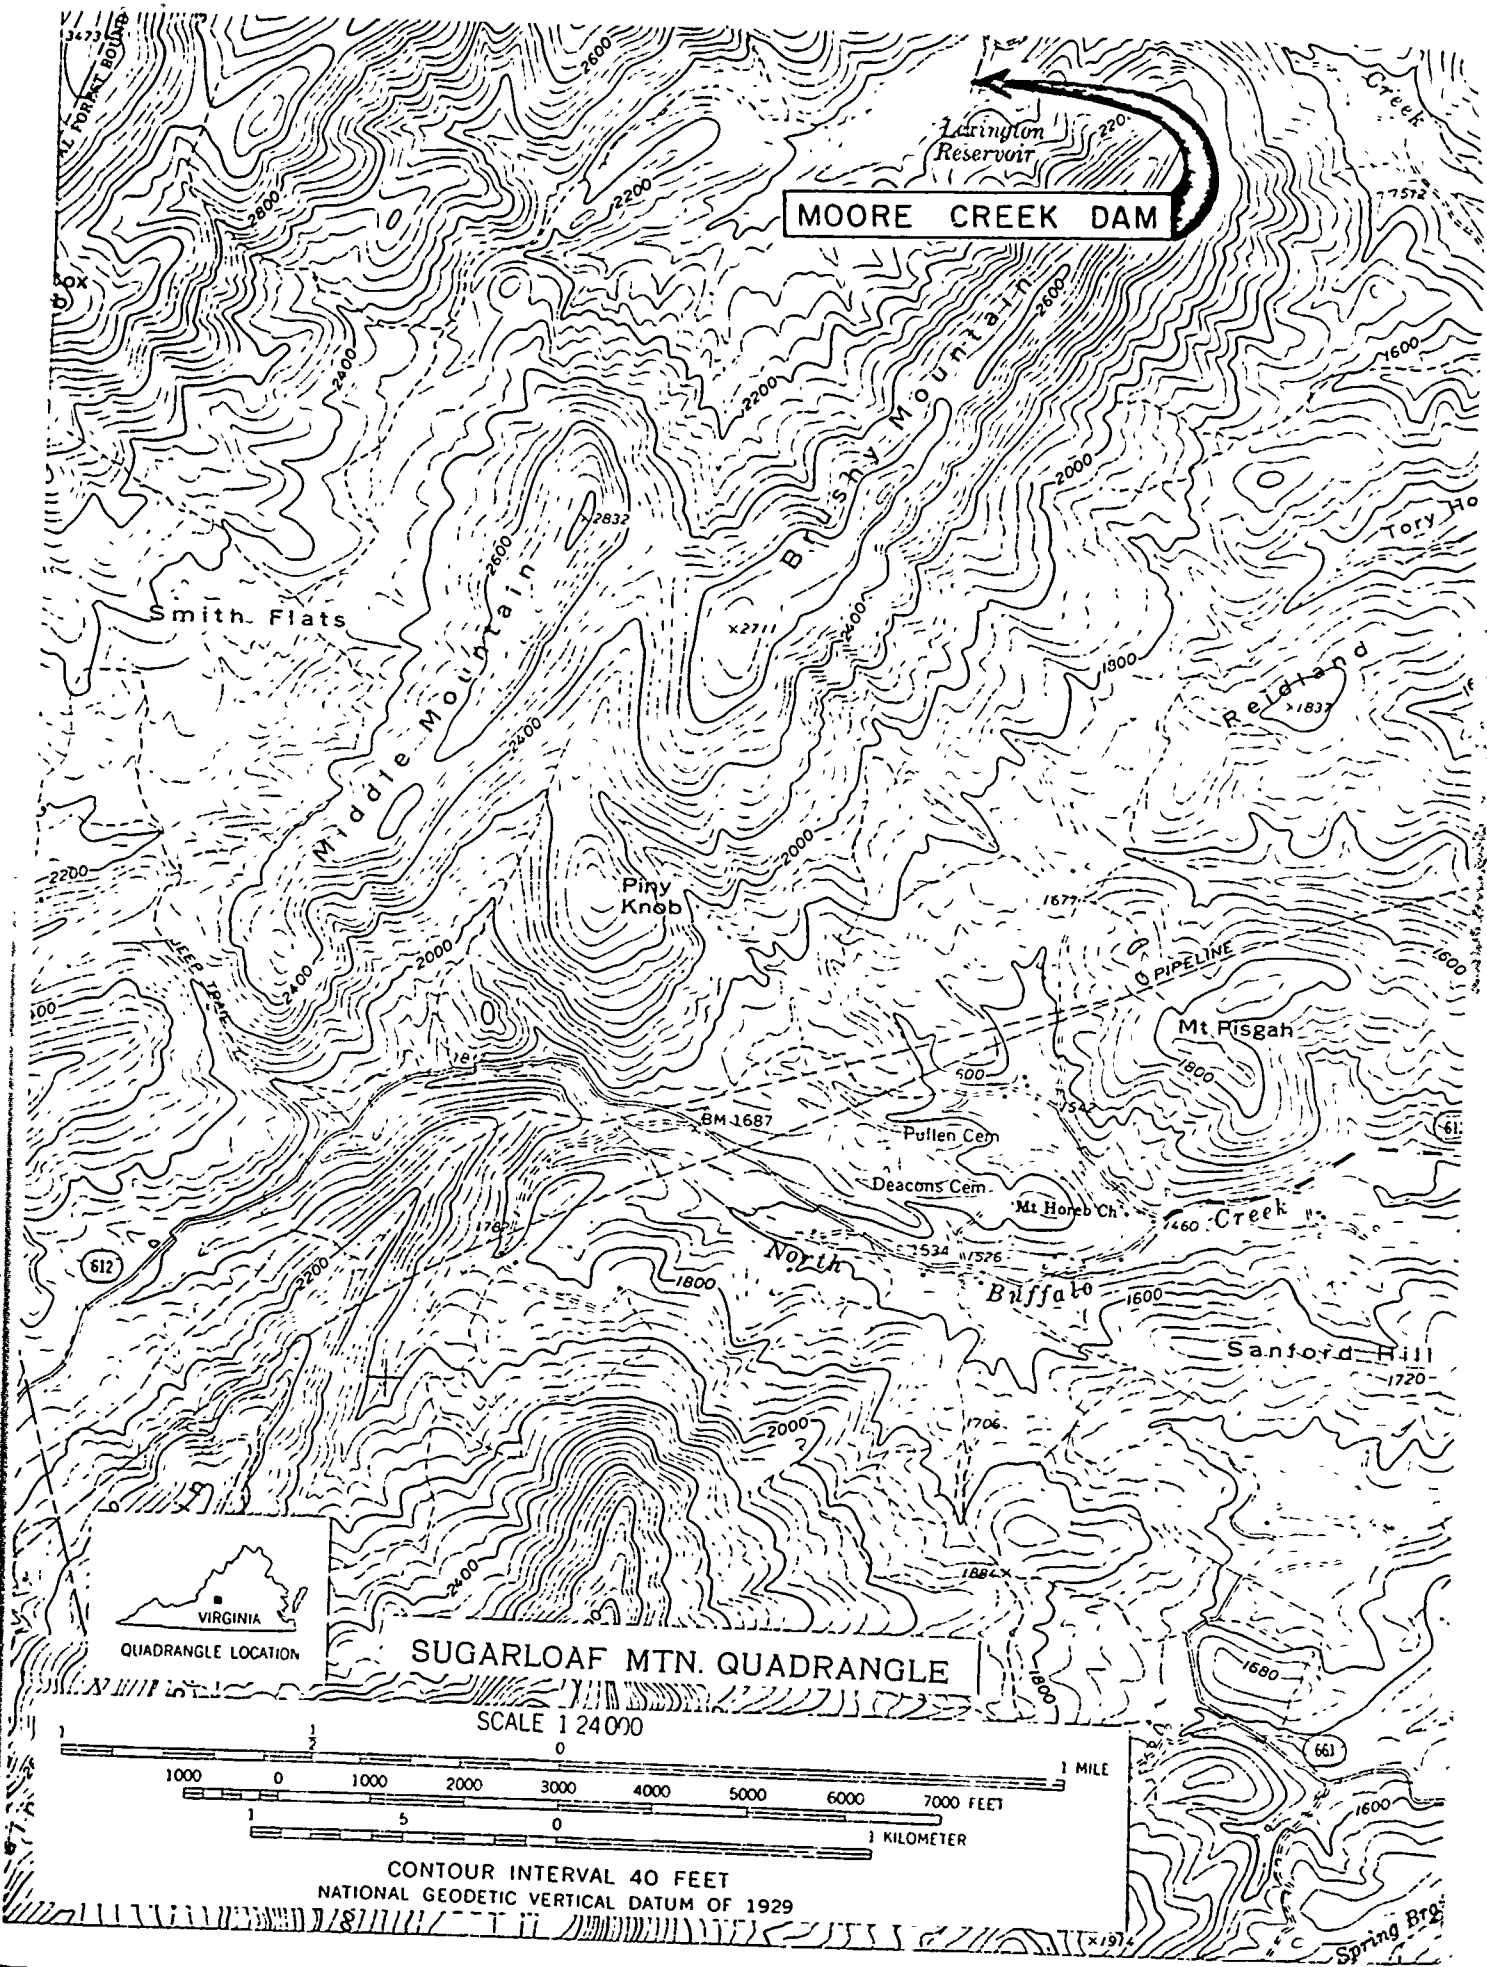
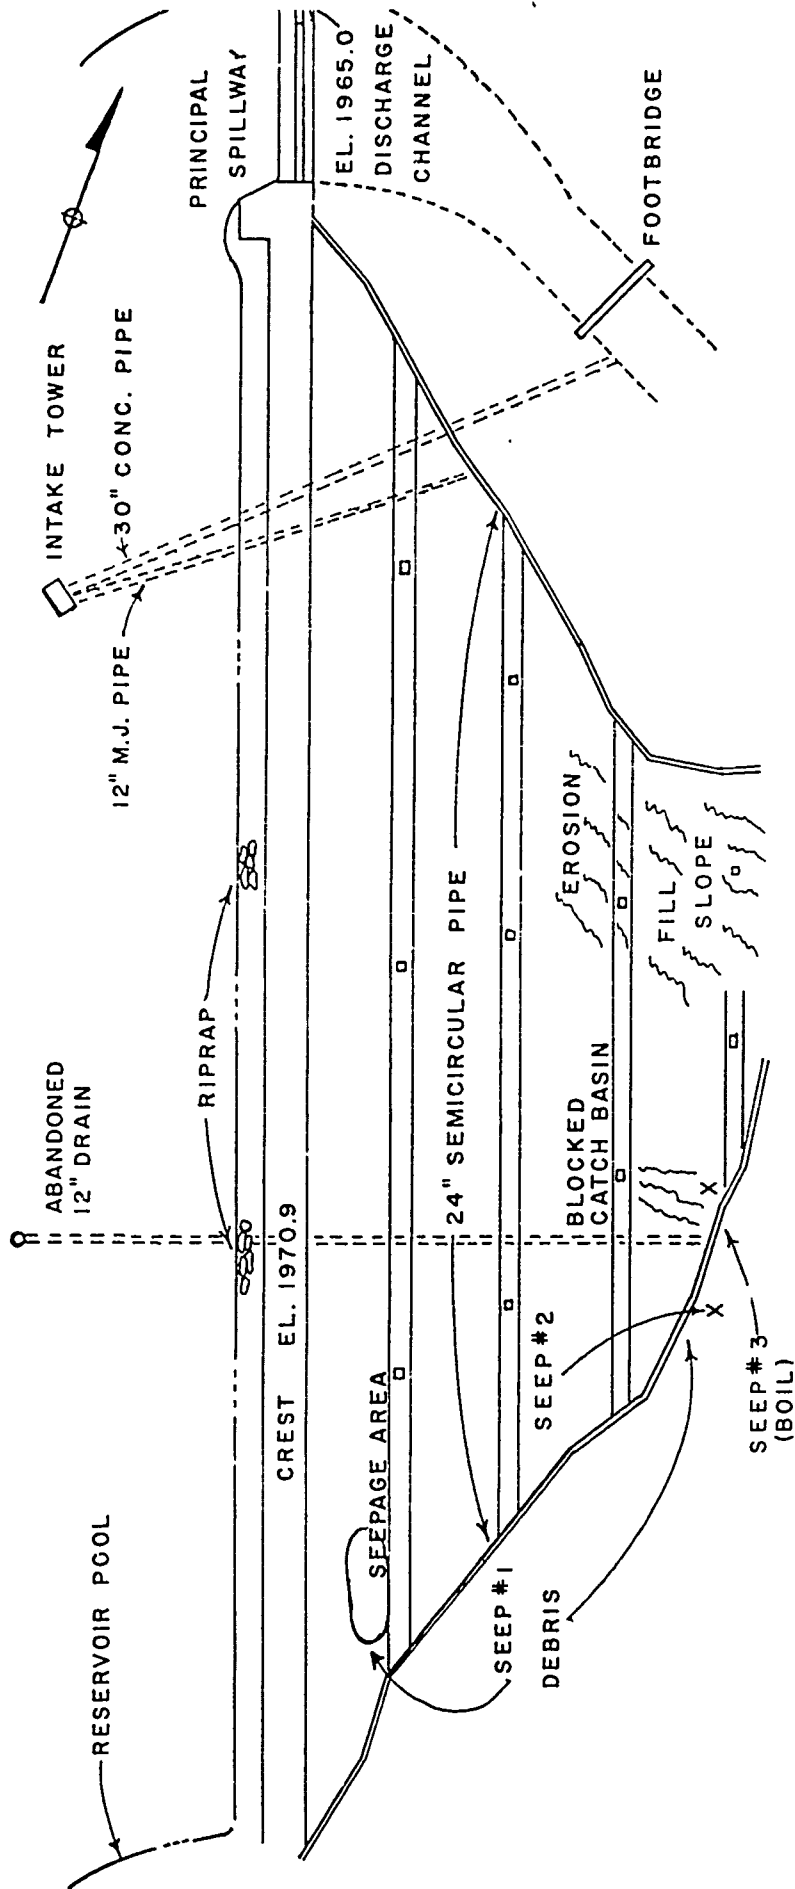
PLAN VIEW

Three seeps were found and are as located on Plate I. Seep 1, shown in Photo 7, is a wet spot. It has created a wet, soggy area about 7 x 25 feet on the downstream slope at the first bench. Seeps 2 and 3 are flowing freely and clearly. No attempt was made to estimate the flow. Seep 3 is a boil and is shown in Photos 9 and 10. It was reported by Wiley and Wilson, that seep 3 is the result of the discharge from a six inch drain tile line which is used to pipe water from an iron water spring which existed in this area.

There are no foundation drains. There is a series of catch basins on the downstream benches. Several were filled with debris. One, as shown on Plate I, is overflowing and there is local ponding surrounding the basin. Also, a gully is developing on the slope just below the basin caused by the overflow. The gully is within the irregular fill.

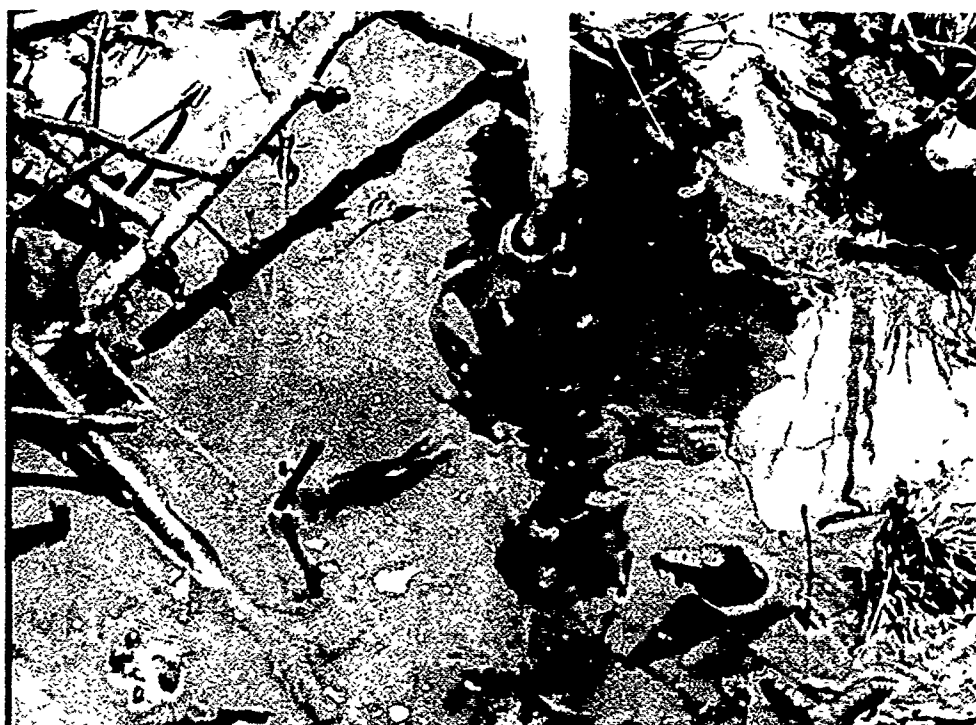
PHOTO #10 CLOSE UP OF "BOIL"
